Manhole Inspection Summary

Manhole # S37E__013MH

Insp Date: **8/29/08 10:19 AM**

Location Address: **148 n gay st**

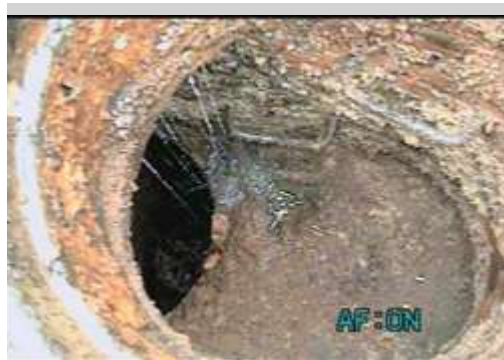
Top View

due to MH construction, this is the best top view phot that could be achieved

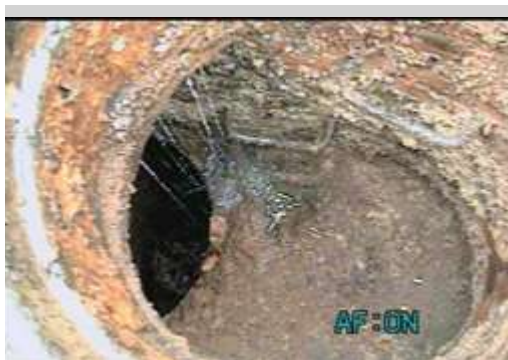
Defect 1

Frame Offset: **0** (in.) Condition: ☐ Sound ☐ Cracked ☒ **Leaks**

Corbel Material: **Brick** ☐ Parged Type: **Concentric/Eccentric**
Condition: ☒ Sound ☐ Cracked ☐ Root Intrusion ☐ Loose Brick ☐ Deteriorated
Infiltration: ☐ None ☒ **Joint** ☐ Cracks ☐ Mortar ☐ Roots ☒ **Wall**

Steps Count: **10** Missing: **0** ☒ **Corroded**

corroded steps; evidence of frame leaking; active infiltration from corbel joint

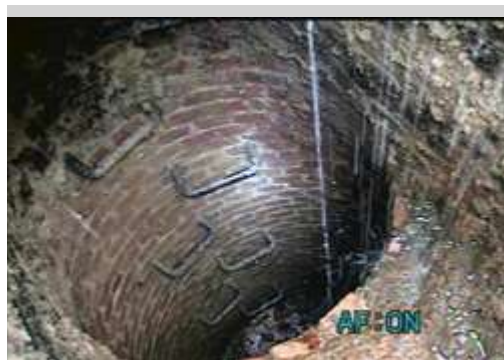
Defect 2

infiltration from corbel wall

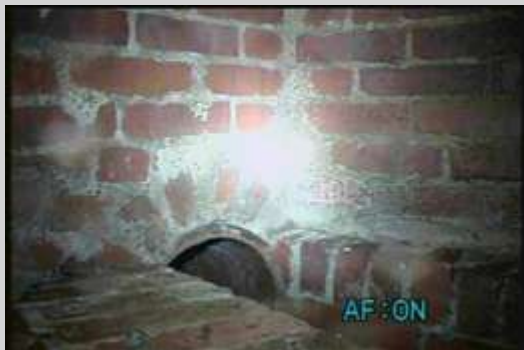
12 O'Clock Outflow

under shelf couldnt get better pic

Infiltration: **None** Pipe Seal Cond: **Unknown**

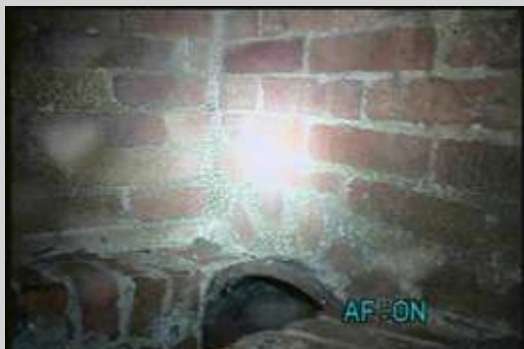
6 O'Clock Inflow

under shelf couldnt get better pic

Infiltration: **None** Pipe Seal Cond: **Unknown**
